Streamwalk 2004

Philipstown, NY

Foundry Brook, Indian Brook, Philipse Brook & Clove Creek

HUDSON HIGHLANDS
LAND TRUST

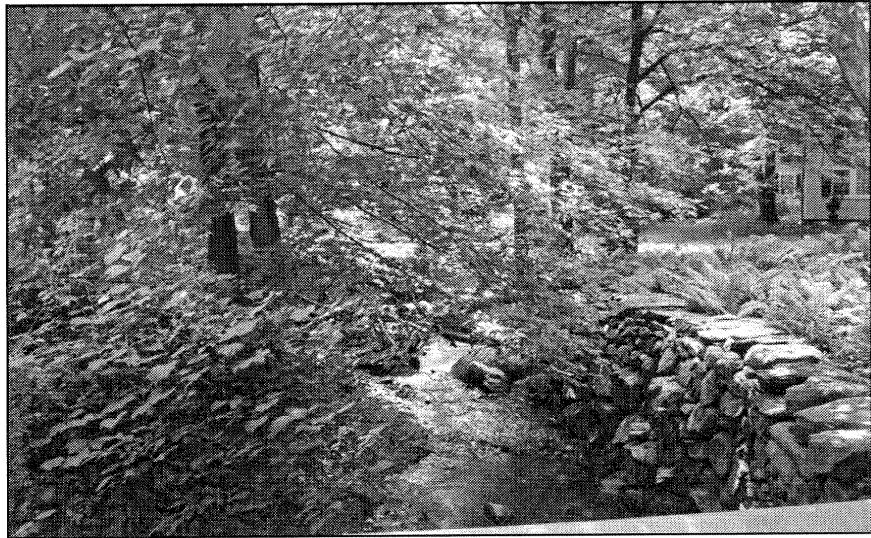
Two stream segments were selected along Indian Brook. IB-1 was located on the western side of the Route 9 bridge and followed downstream approximately .4 miles. The surrounding land use is rural and the area is privately owned. Depth measured an average of 7.5 inches across the segment. Stream width was an average of 14.75 feet. The calculated average velocity of the stream segment was .44 cf/sec. Stream banks were stable along the segment, and a high score was given for stream cover and width of riparian zone. Water appeared clear and very little litter was seen. Pools were present and approximately 20 fish were

seen in each. A blue heron and a white heron are known to frequent these ponds. The only fish barrier along the segment was the culvert at the Route 9 bridge. Rocks in the silt-covered streambed were greater than 75% embedded. The overall habitat assessment score was *Fair*.

IB-1 from Indian Brook Road looking downstream

Interviews with landowners along IB-1 revealed a recent increase in flood events related to increased sedimentation of the stream. Generally, as rocks become embedded, there is less rock surface or space between rocks available as habitat for aquatic macroinvertebrates and for fish spawning. More investigation into the recent change in the stream's physical characteristics is recommended.

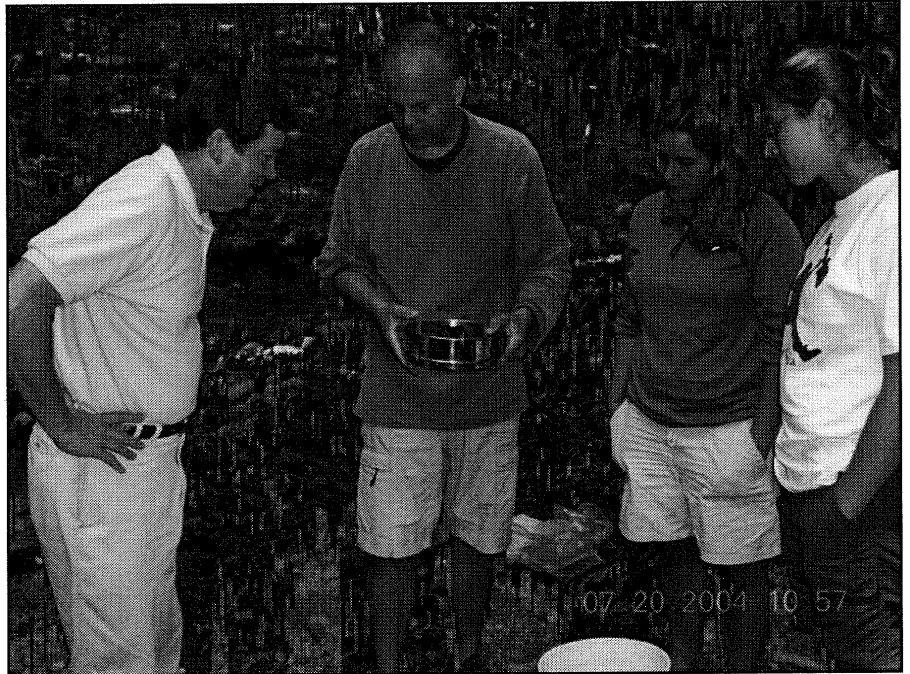
The second segment, IB-2 flowed .15 miles downstream from the NYC Aqueduct land. A visual assessment was completed at IB-2 while collecting a macroinvertebrate sample. The stream segment meandered through a forested area at the base of a narrow ravine. Water was very clear and small brown trout were identified. Stable banks and a riparian zone atleast twice the size of the active channel characterized the segment. A spring fed perennial stream flowed into the stream segment. The overall score IB-2 was *Excellent*.

Macroinvertebrates were collected at IB-2 and results indicated the stream segment was *non-impacted*. Sample analysis results indicate a high diversity of macroinvertebrate organisms, with 22 Families identified. Perlidae, commonly known as stoneflies, were the most common, representing 17% of the sample.

Collecting macroinvertebrates at IB-22

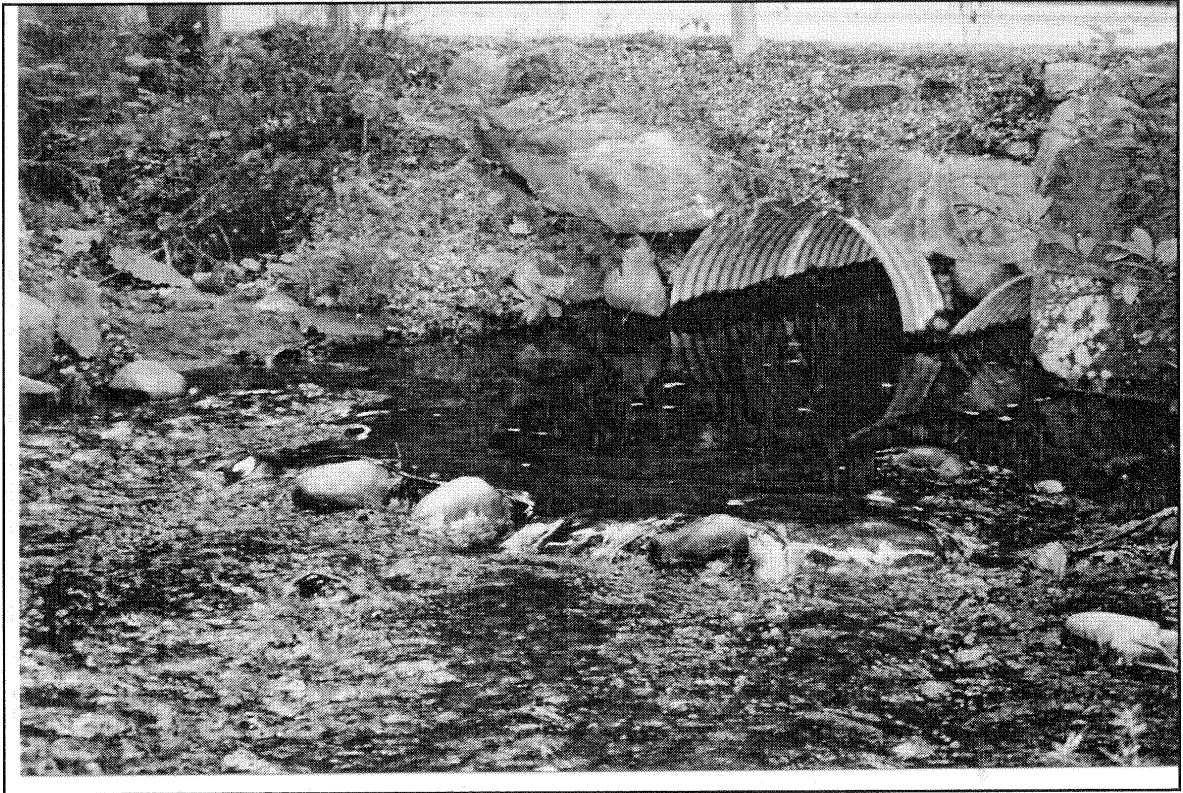
Downstream from Earl's Pond and west of Old Albany Post Road, PB-2 followed Philipse Brook Road and received an overall score habitat assessment score of Fair. The average depth of water along the stream was 1'1" and the average width of the stream was 14'8". Average velocity of flow was 1.5 *cf/sec*. This segment survey was completed 3 days after a heavy rainstorm that brought approximately 3 inches of rainfall in less than 12 hours. A natural riparian zone and streamside cover existed on only one side of the stream; the other side of the stream was adjacent to Philipse Brook Road. Few pools were present along the segment. Small areas of erosion along the streambank and evidence of past channel alteration were visible from this roadside assessment. Remnants from an old pulley, pump house pipes and old dams remain in the stream. More recent anthropogenic impacts include driveway crossing and stormwater discharge pipes. Litter was fairly common and seemed purposely dropped. Wild

Stormwater discharge pipe at PB-2

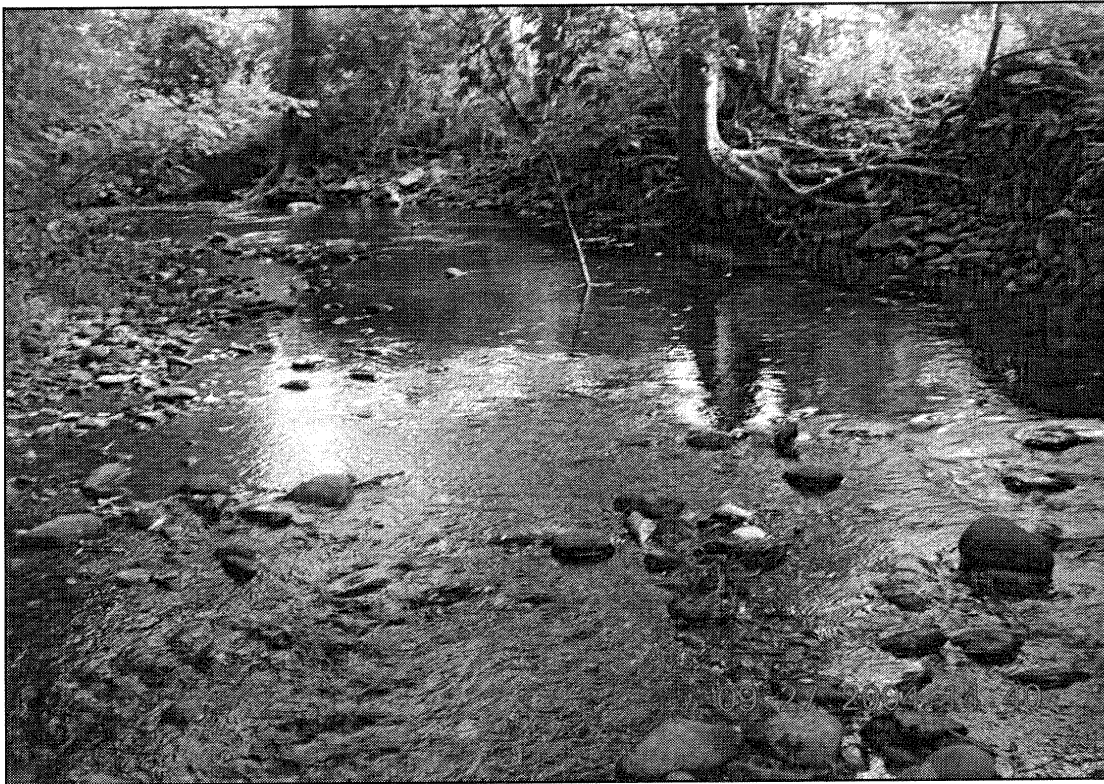
Macroinvertebrates were collected at PB-5 and the results indicate the segment to be *slightly to non-impacted*. The segment was approximately .15 miles just above the Route 9D bridge. The overall habitat assessment score for PB-5 was *Excellent*. Natural vegetation extended at least one active channel width and the canopy cover was greater than 60% of the stream. Water was clear with little sign of nutrient enrichment and a diverse aquatic plant community was noted. The meandering stream had pool and riffle characteristics and surrounding landuse was rural residential.

PB-5 Macroinvertebrate collection site

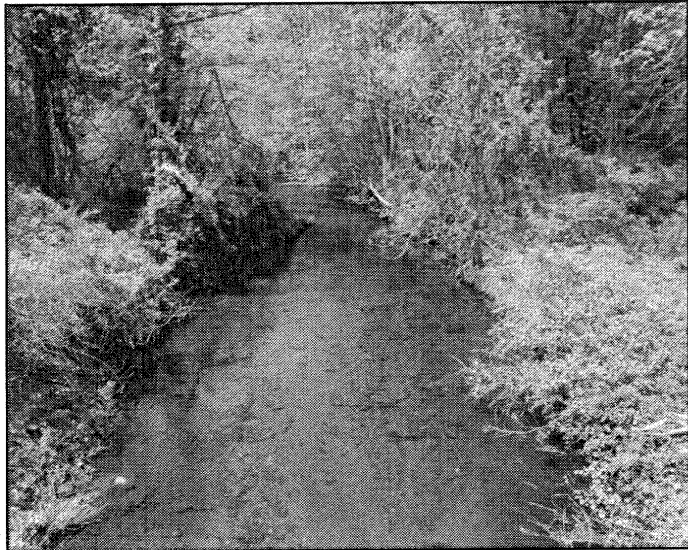
The stream continues to flow north along Route 9. CC-3 began at the bridge on Route 9 and followed the stream 1/5 mile to the bridge at Old Albany Post Road North. The overall habitat assessment score was *Good*. The surrounding landuse is a mix of commercial and residential with industrial uses nearby. There is a large paved parking lot in proximity to the segment. Impervious surfaces can negatively affect a stream by increasing the rate and

CC-3 Stream corridor

temperature of stormwater runoff that enters the stream. Average width of the segment was 24' and average depth was 2.2'. Weather conditions were overcast and dry, with no precipitation in the previous 48 hours of the segment survey. The air temperature was 70F and water temp was 62F at 1:00PM. The average velocity of the stream was calculated to be 12cf/sec. No dams were identified on the segment but 2 individual drainpipes diverting stormwater from Route 9 were identified. Natural vegetation extended at least 2 active channel widths and the canopy covered 40% - 60% of the stream. Banks along the segment were moderately stable with small areas of erosion near Route 9. The channel naturally meandered and no barriers to fish movement were present along the segment. Water appeared very clear and no litter was found. One great blue heron was seen along the segment, as well as a dead 14" brook trout and a dead crayfish.

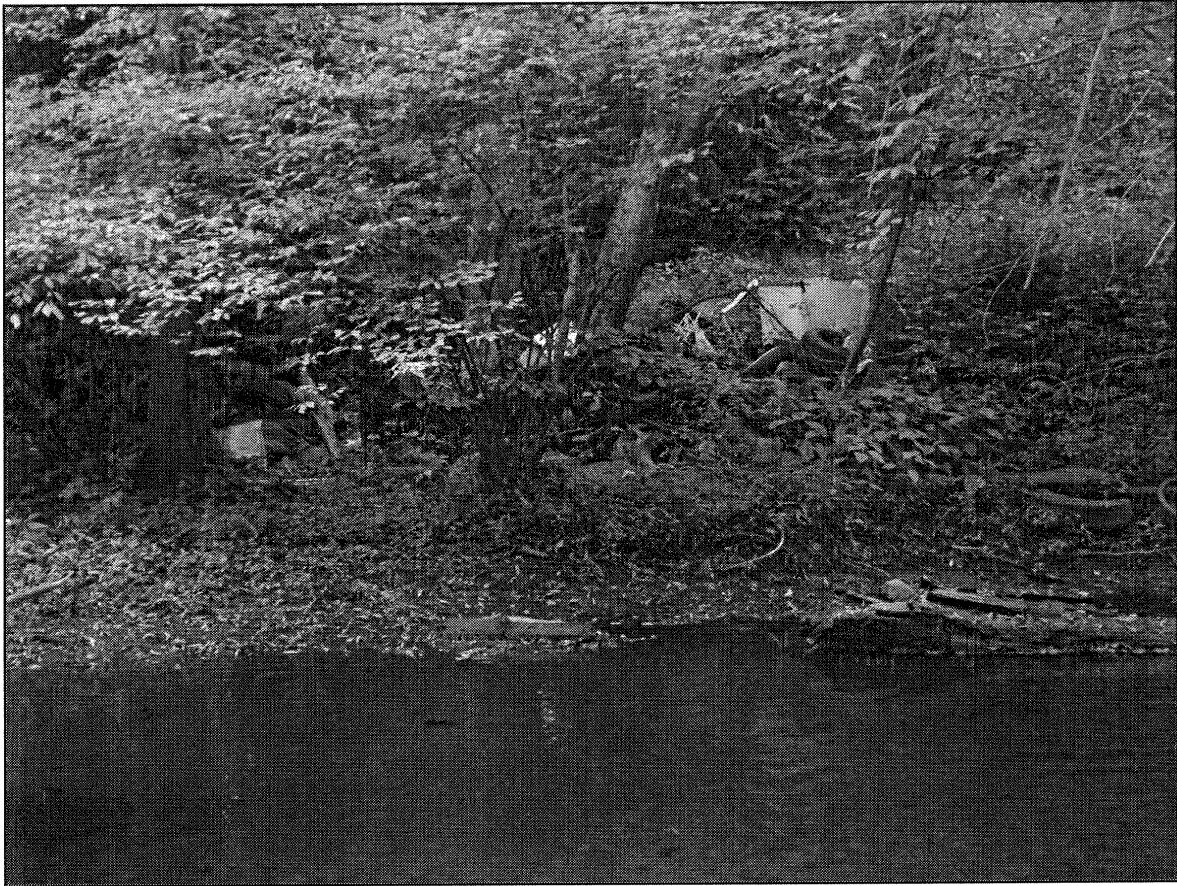
Trash along shore at CC-4

The northern most segment of Clove Creek, CC-4 extended from Albany Post Road to Snow Valley Campground. A detailed habitat assessment and water quality analysis of CC-4 was completed over 2 days and is available on Table 1. In general, stream vegetation and insects were absent. Silt and mud was prevalent and the substrate was greater than 75% embedded. Pools were absent along a majority of the segment. CC-4, while just downstream from CC-3 showed signs of environmental stressors. Sections of discolored water, discharge pipes and trash were noted. Surrounding industrial land uses may be negatively impacting this section of Clove Creek. More investigation is recommended to identify the impact of surrounding landuse on this important drinking water source.

- *To help reduce the impact of litter while raising awareness of our water resources, sponsor "Streamside Cleanup Days"*
Litter appeared purposefully dropped along at least two segments during the physical assessment survey. To help reduce the impact of litter and compliment existing enthusiasm among roadside cleanup volunteers, develop clean up days along streams. Programs including "adopt a stream" could involve existing volunteer or hobby groups, school children and civic associations.
